## 2013 OPA Winner: Wolf Creek Dam Rehabilitation

Michael F. Zoccola, P.E., USACE and Fabio Santillan, TSJV project manager, Treviicos

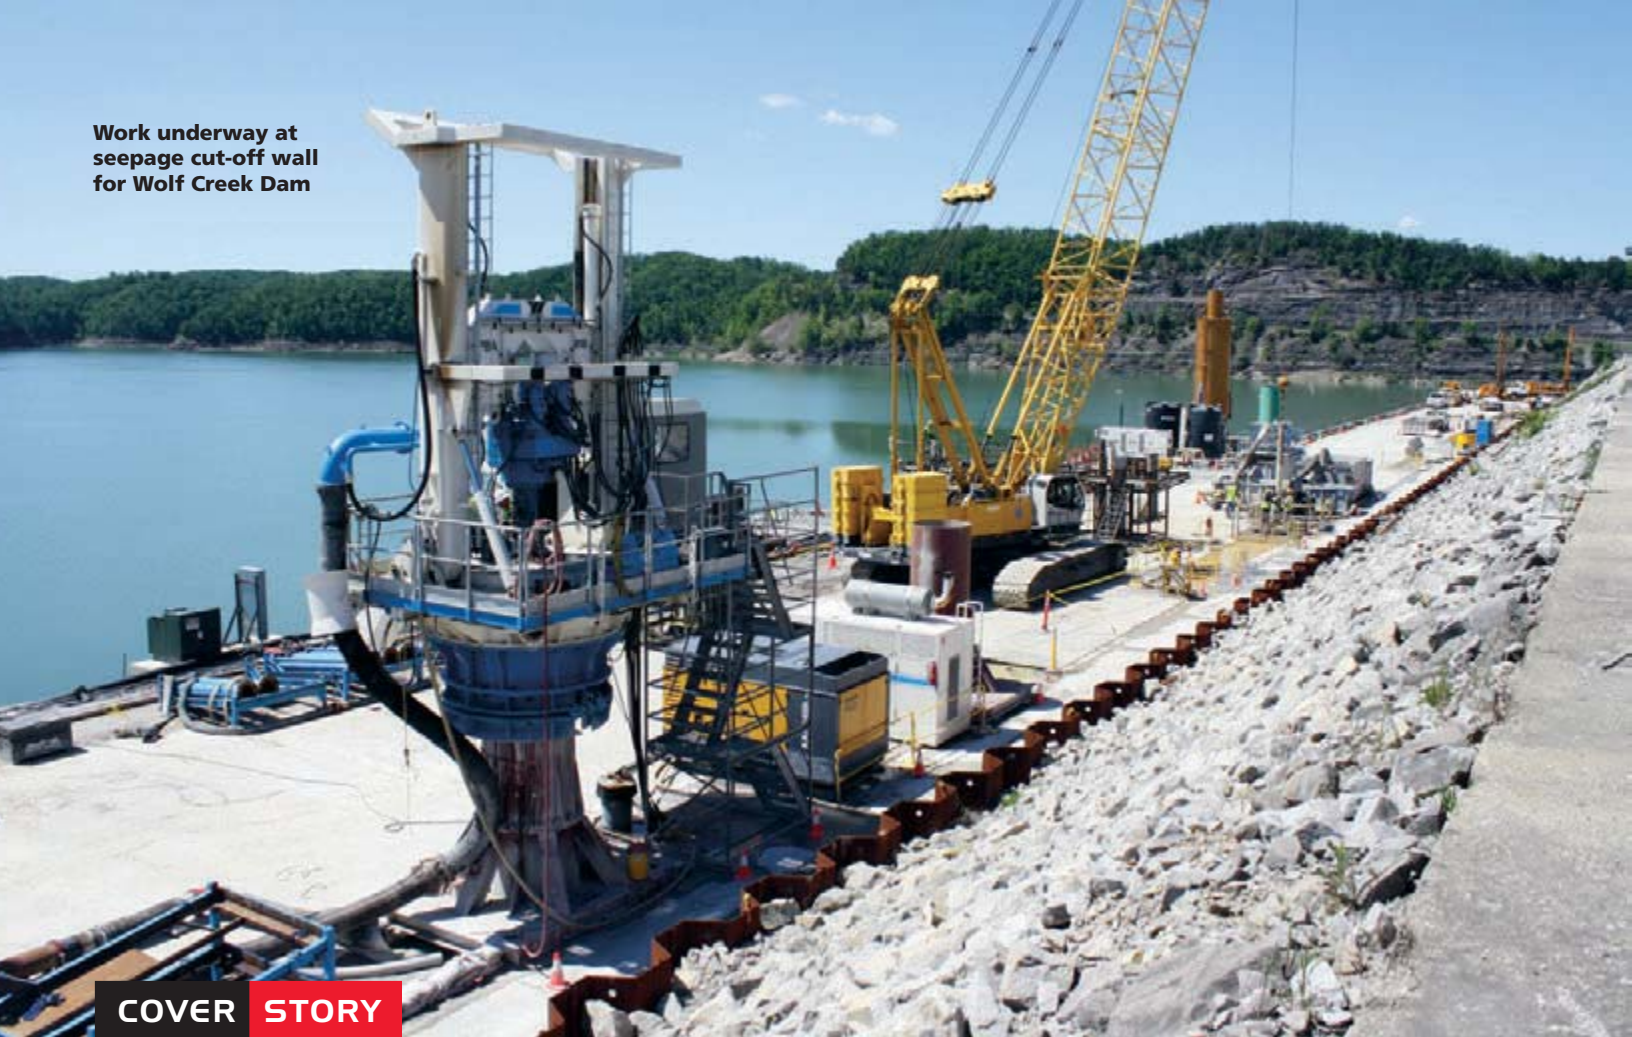
Work underway at  
seepage cut-off wall  
for Wolf Creek Dam

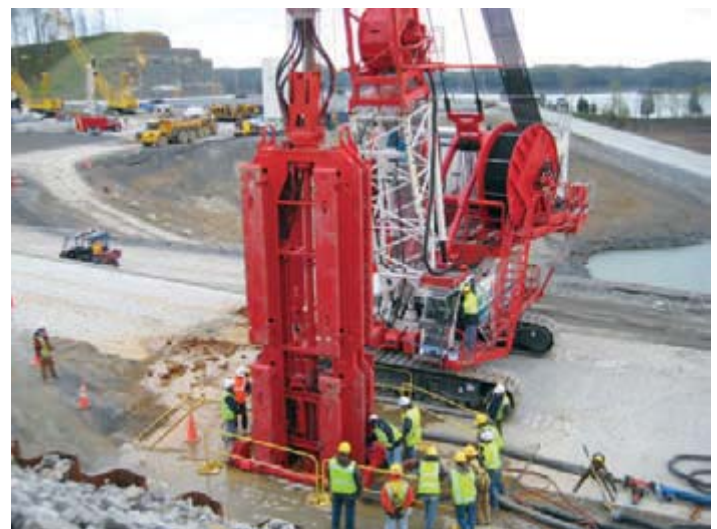
**The hydromill is inserted into a steel guide frame locked into guide walls on the work platform, allowing the mill to begin excavation at the right location in a vertical position**

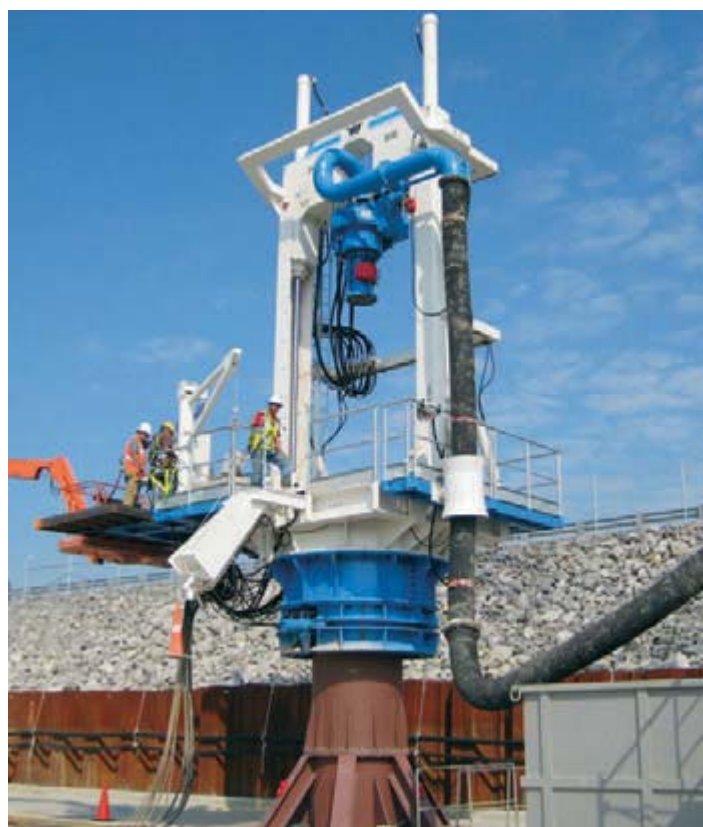
**The Wirth drill being installed atop casing bolted to the work platform at surveyed locations**

Piles were installed using a Wirth drill rig. The bottom hole assembly of the drill has a roller rock bit face that was fitted with a 2 ft (0.6 m) stinger to fit inside and follow the guide hole. The bottom hole assembly on the Wirth had on-board inclinometers that provided verticality data to the operator. The Wirth drill had no steering capability. It relied on the stinger to follow the guide hole, the 60 ft (18.3 m) long bottom-hole assembly riding inside the pile hole, and the dead weight (~ 70 tons) to maintain the location and
